# Manhole Inspection Summary

Manhole # S27G\_\_027MH

Insp Date: **6/21/08 9:18 AM**

**Location** Address: **16 S Poppleton**

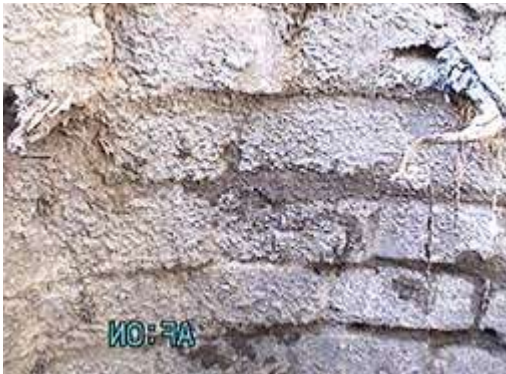
Defect 1

Count: **4** Missing: **1** ☐ Corroded

missing steps & corroded

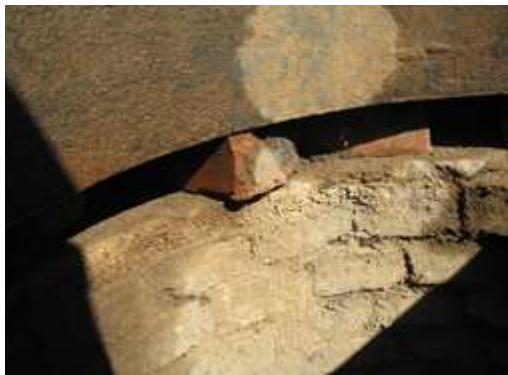
Defect 3

Condition: ☐ Sound ☐ Cracked ☒ **Leaks**

infiltration from gap frame chimney

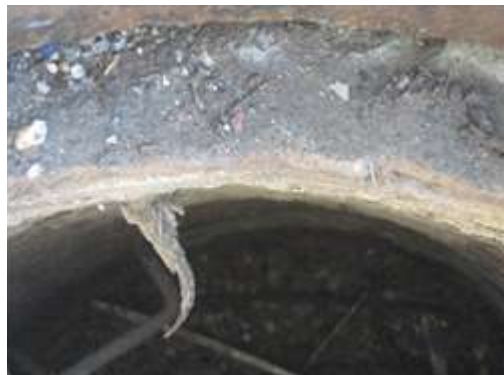
Defect 4

Offset: **2** (in.)

offset 2 inches

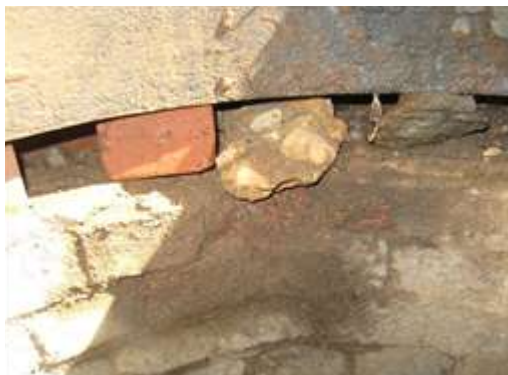
Defect 2

Condition: ☐ Sound ☐ Cracked ☐ Root Intrusion ☒ **Loose Brick** ☐ Deteriorated

Infiltration: ☐ None ☒ **Joint** ☐ Cracks ☒ **Mortar** ☐ Roots ☐ Wall

chimney cond loose bricks, joint, mortar

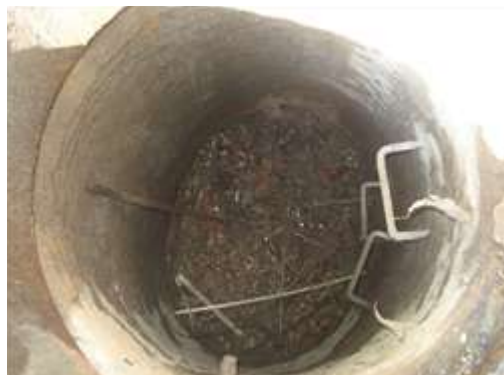
Defect 5

Condition: ☐ Sound ☐ Cracked ☐ Root Intrusion ☐ Deteriorated ☐ Leaks ☒ **Debris**

Bench & Channel Debris. Evidence of Surcharge
